RC
1042
.M38
1990a
c.2

Department
of Transportation
National Highway
Traffic Safety
Administration

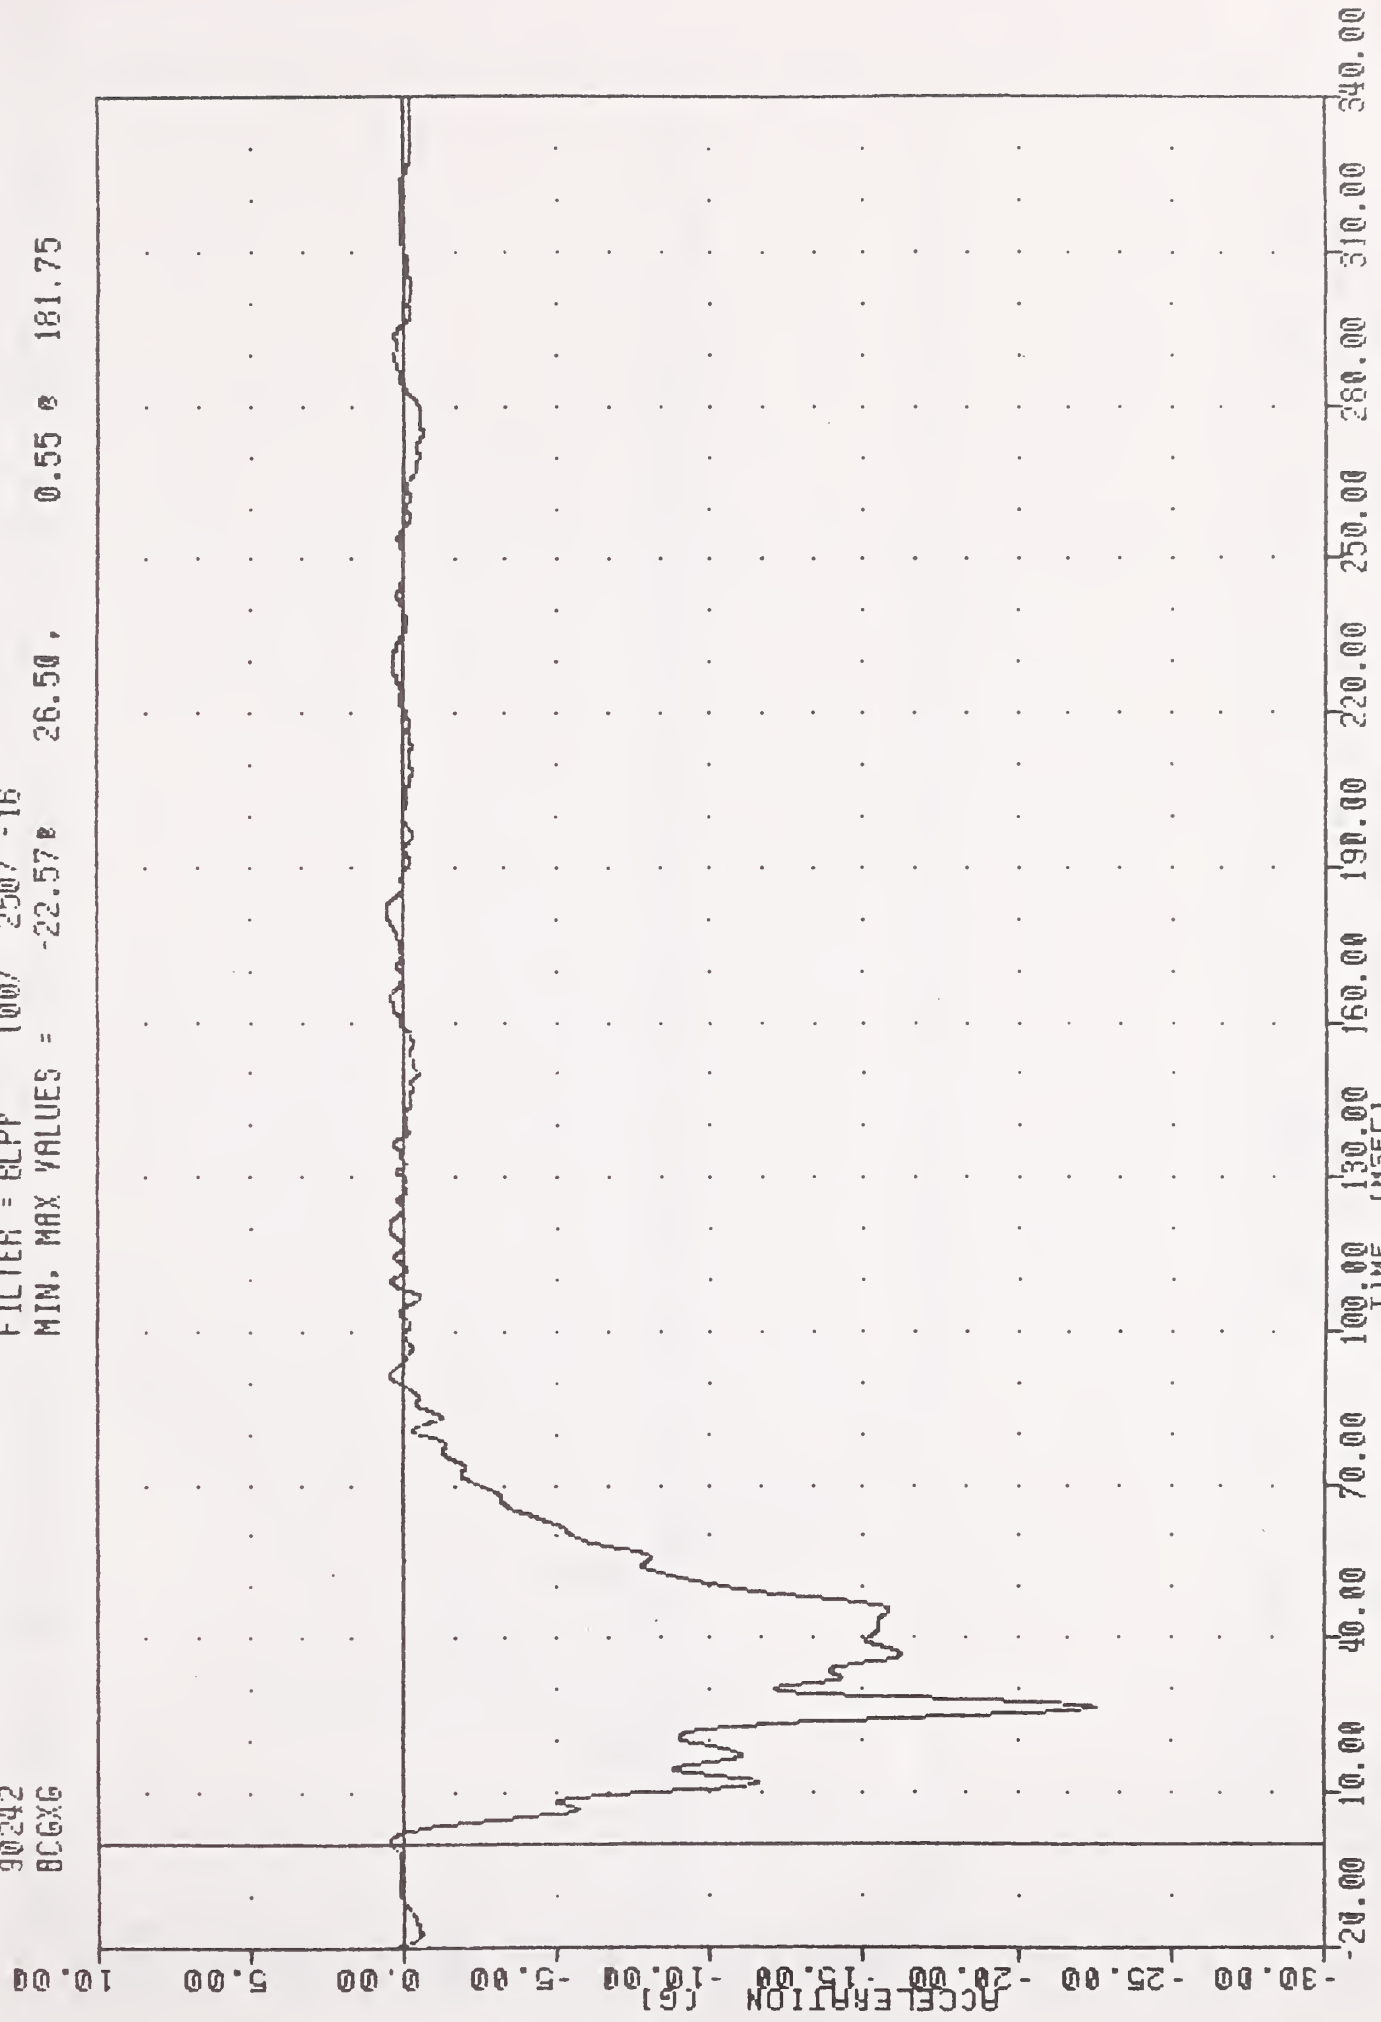
CONTOURED MOVING BARRIER INTO FORD ESCORT AT 28.1 MPH #2
 MOVING BARRIER CENTER OF GRAVITY X-AXIS ACCELERATION

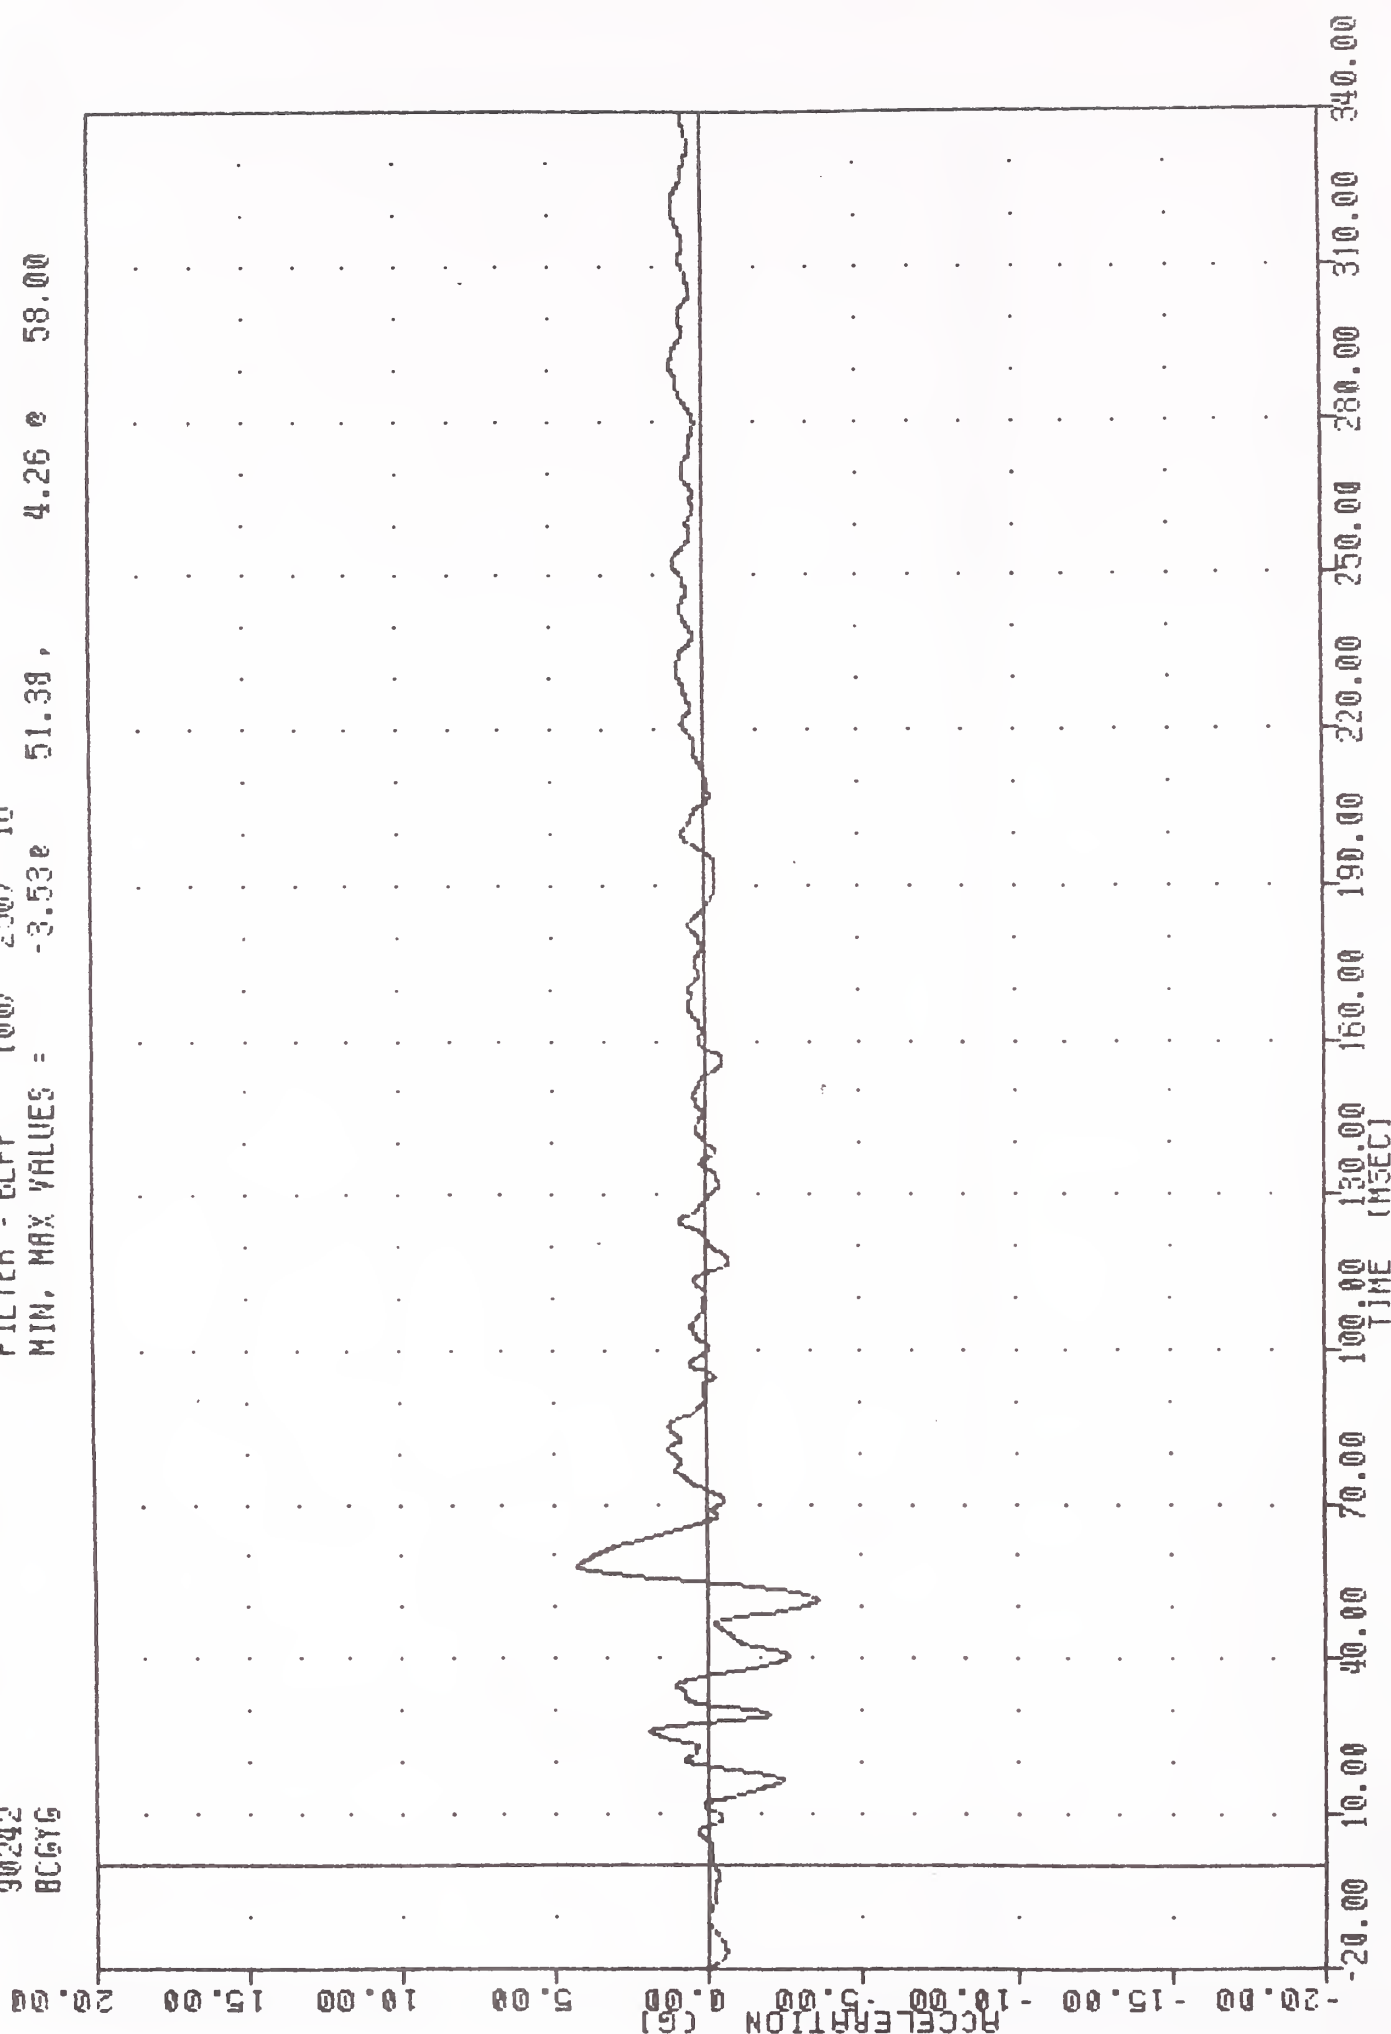
CONTOURED MOVING BARRIER INTO FORD ESCORT AT 28.1 MPH *2
 MOVING BARRIER CENTER OF GRAVITY Y-AXIS ACCELERATION

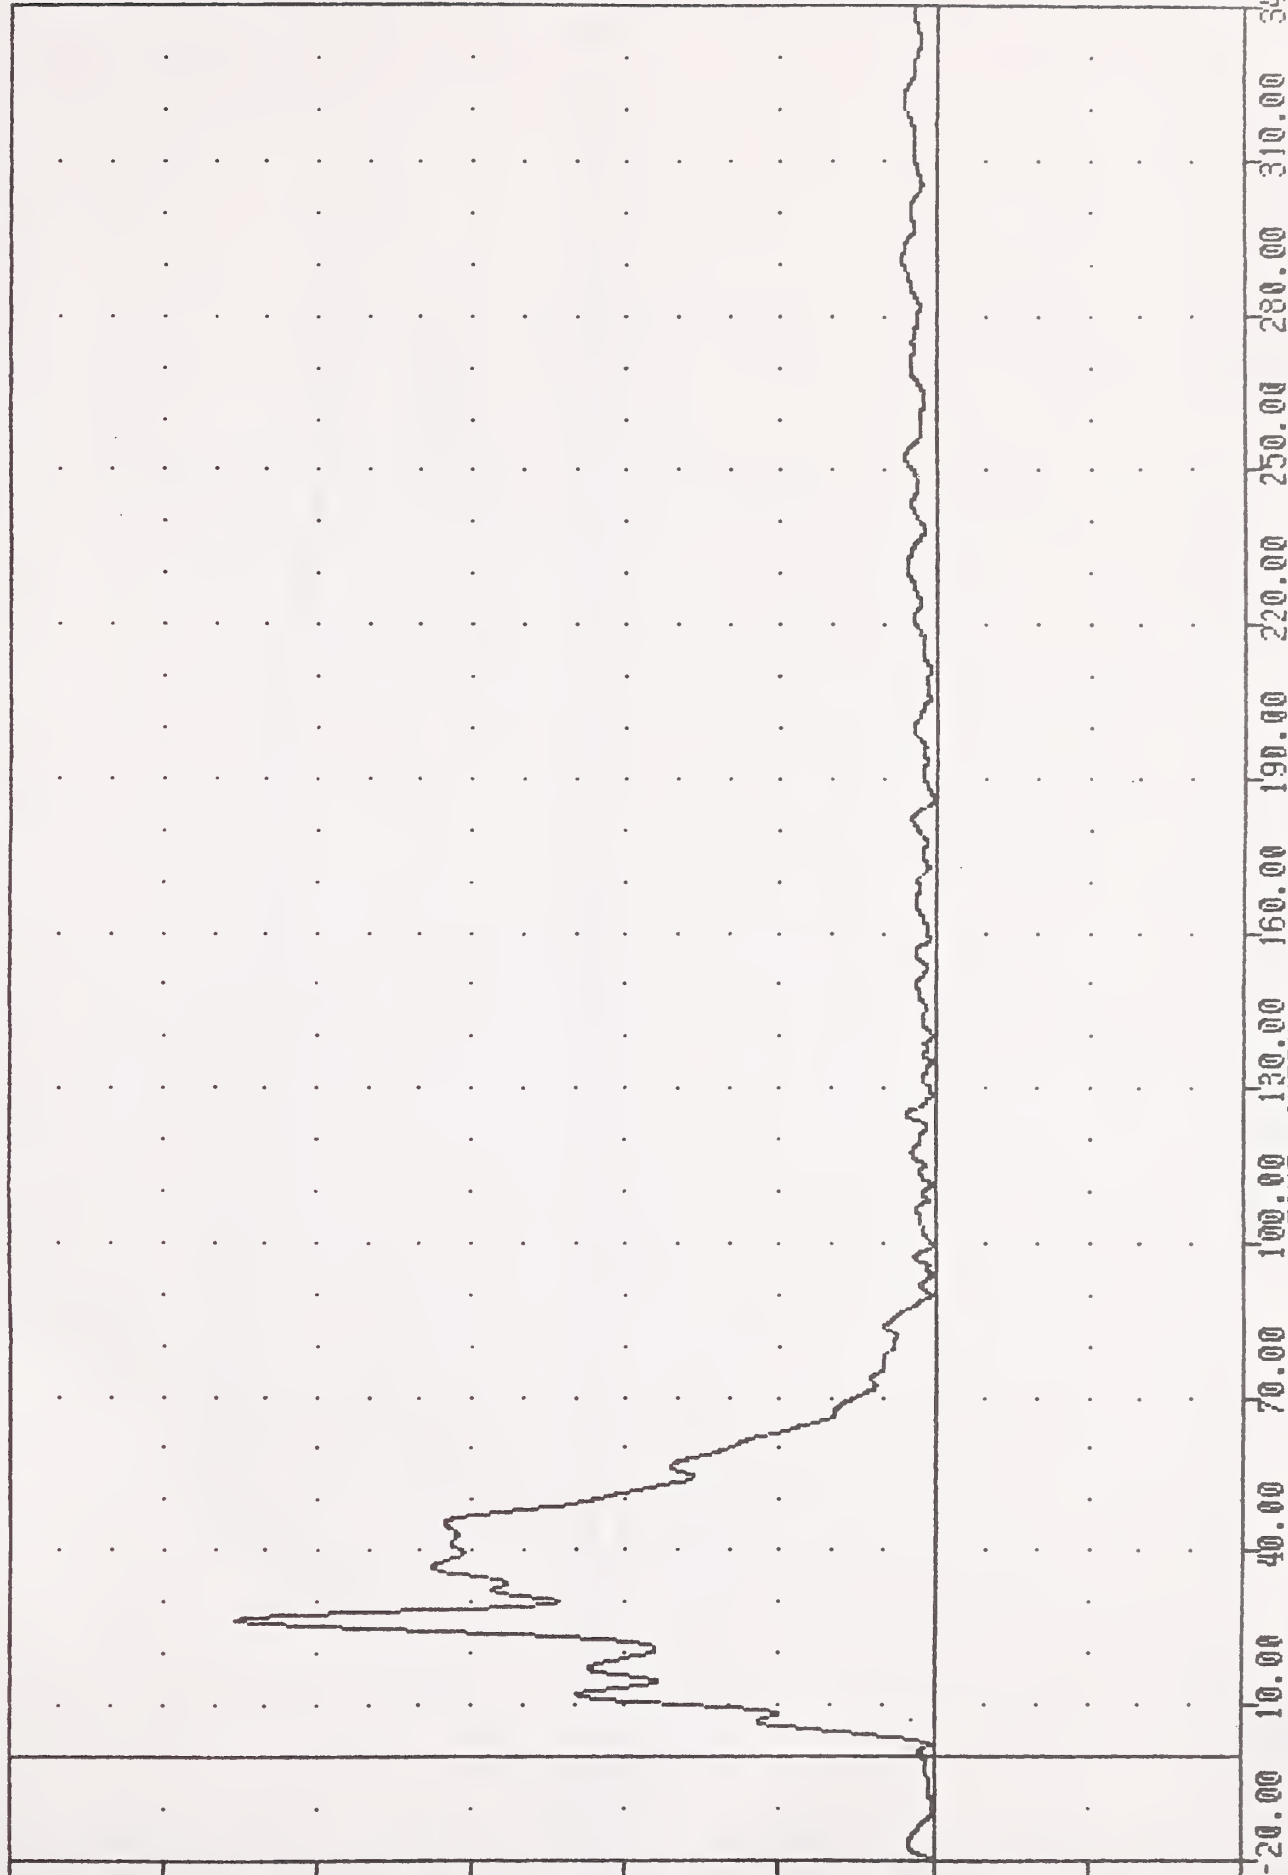
900330-2 , TRC
 CRASH III DAMAGE ALGORITHM
 90242
 LFSXV1

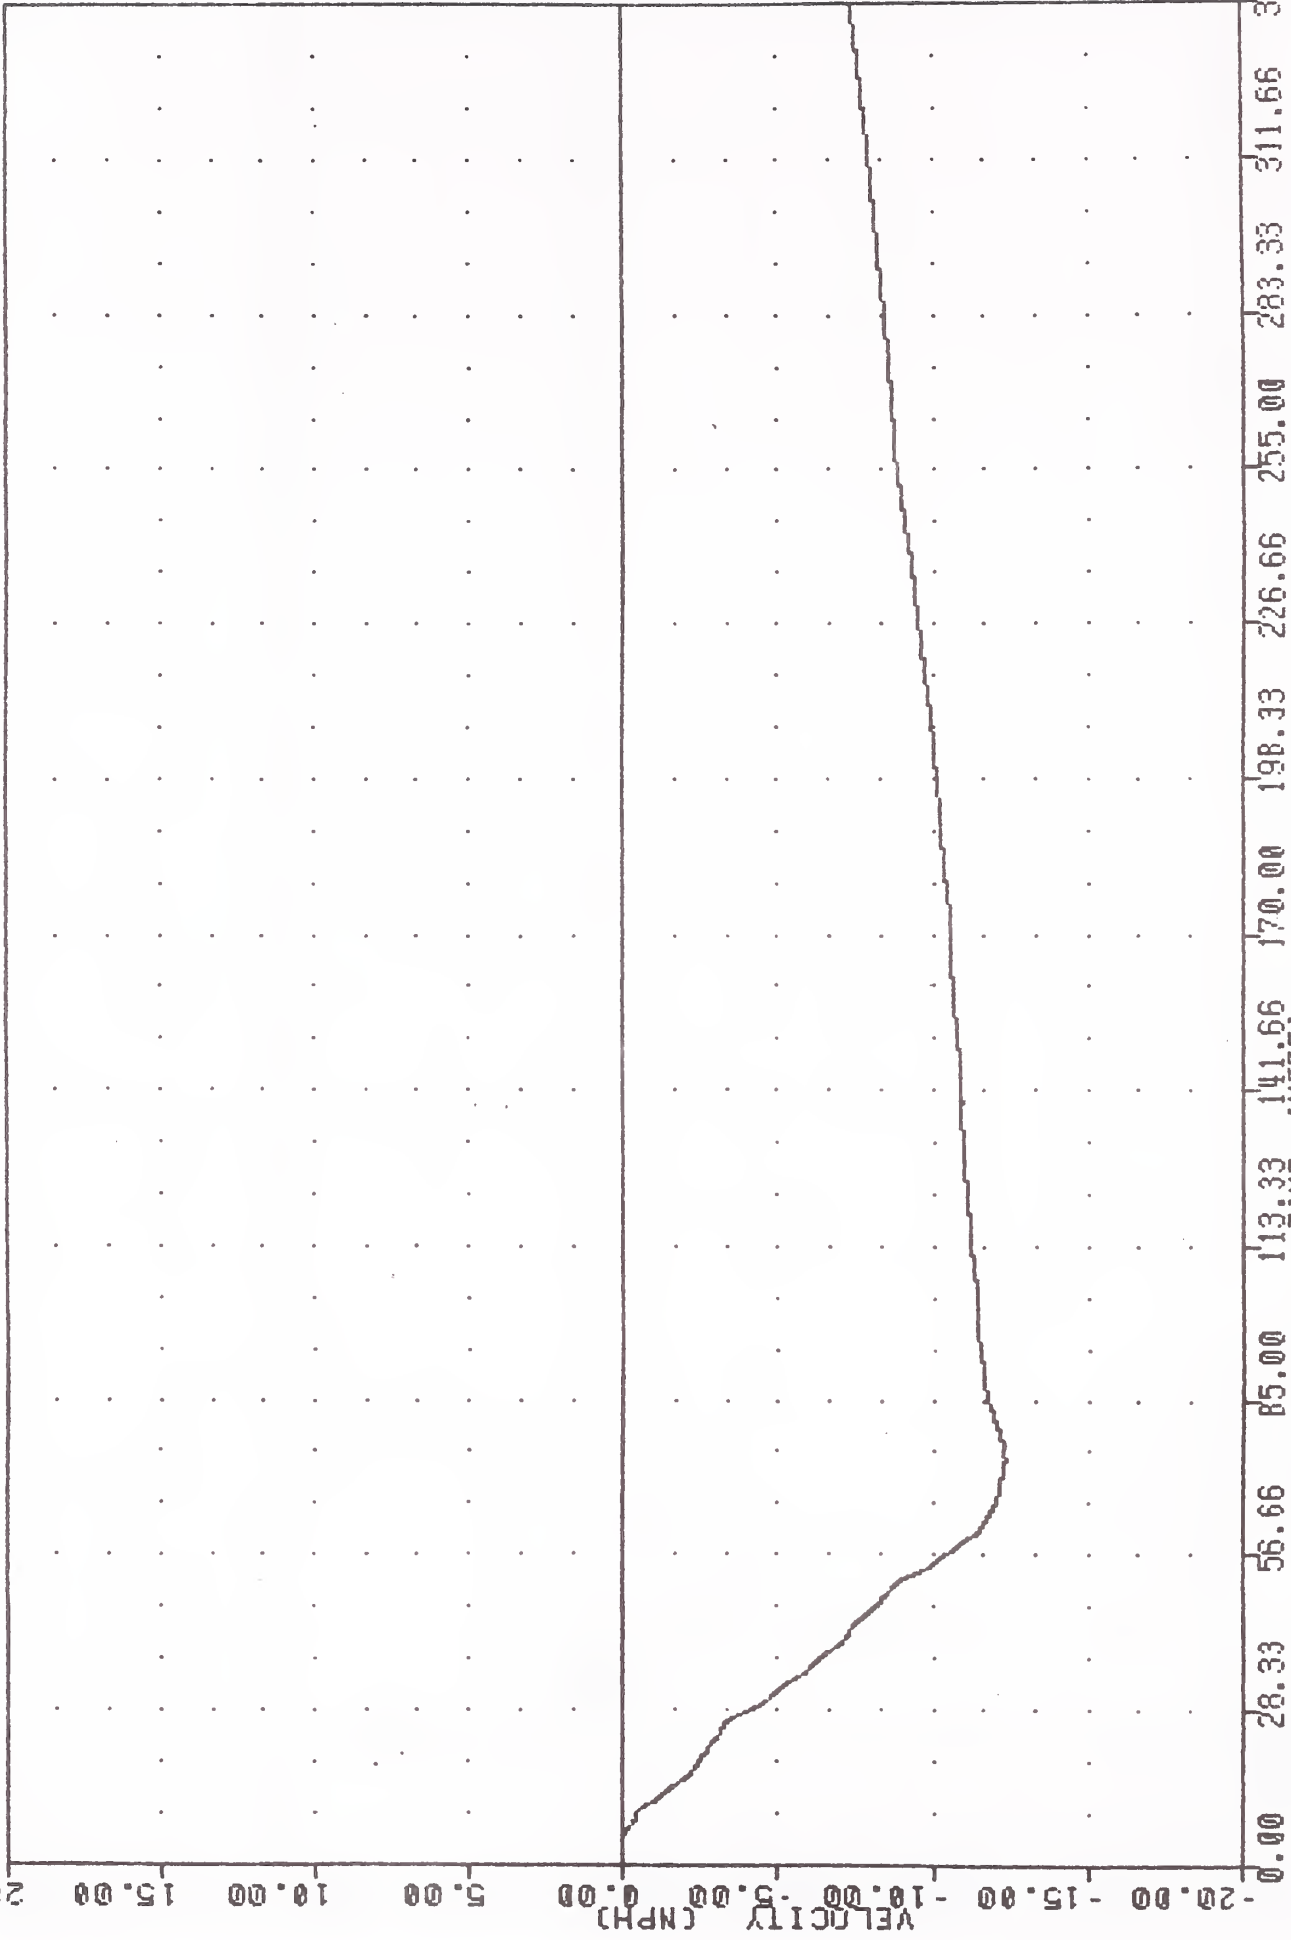
CONTOURED MOVING BARRIER INTO FORD ESCORT AT 28.1 MPH #2
 LEFT FRONT STILL X-AXIS VELOCITY

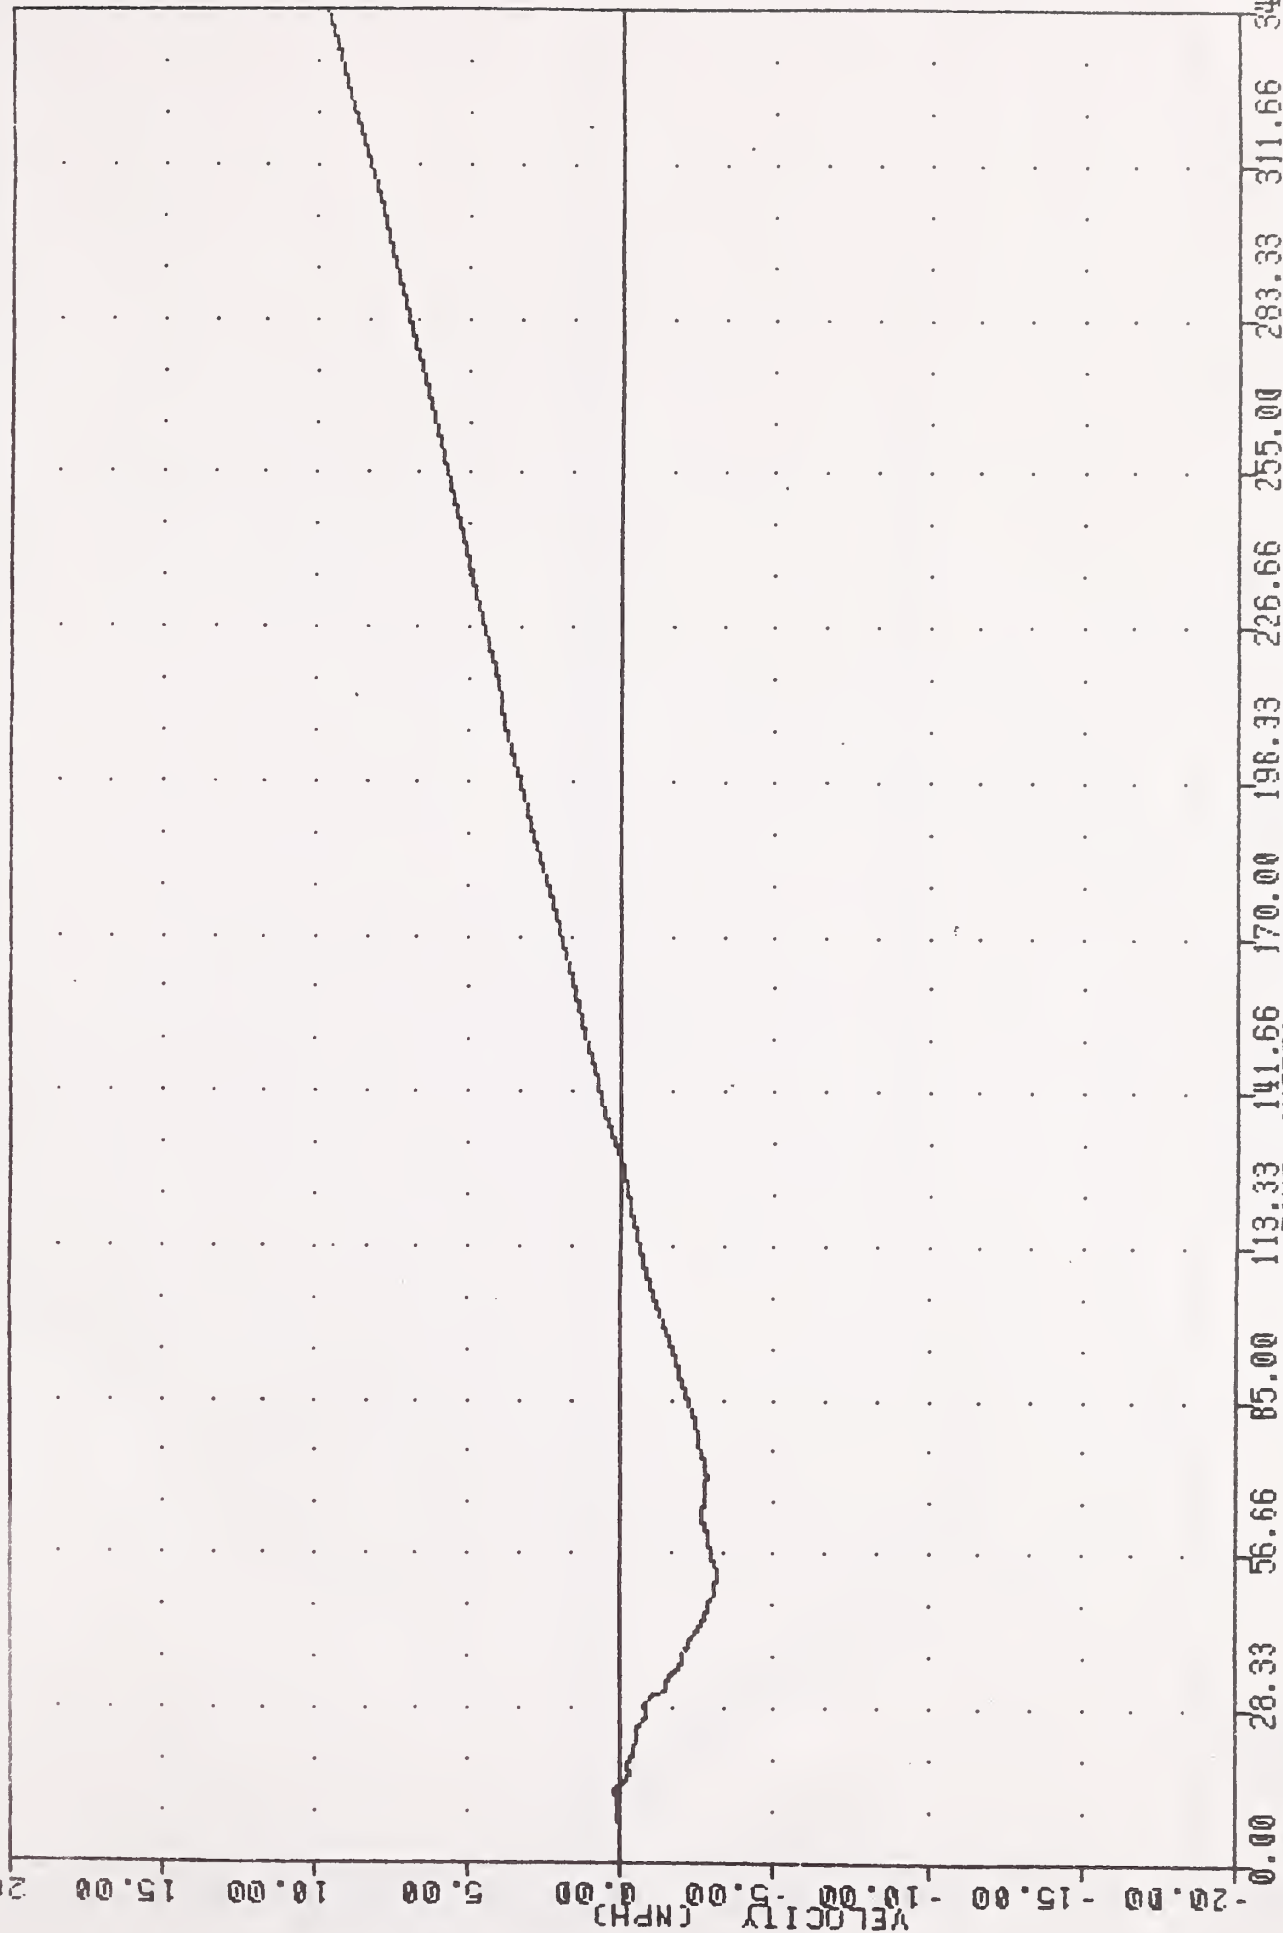
CONTOURED MOVING BARRIER INTO FORD ESCORT AT 28.1 MPH #2
 LEFT FRONT SILL Y-AXIS VELOCITY

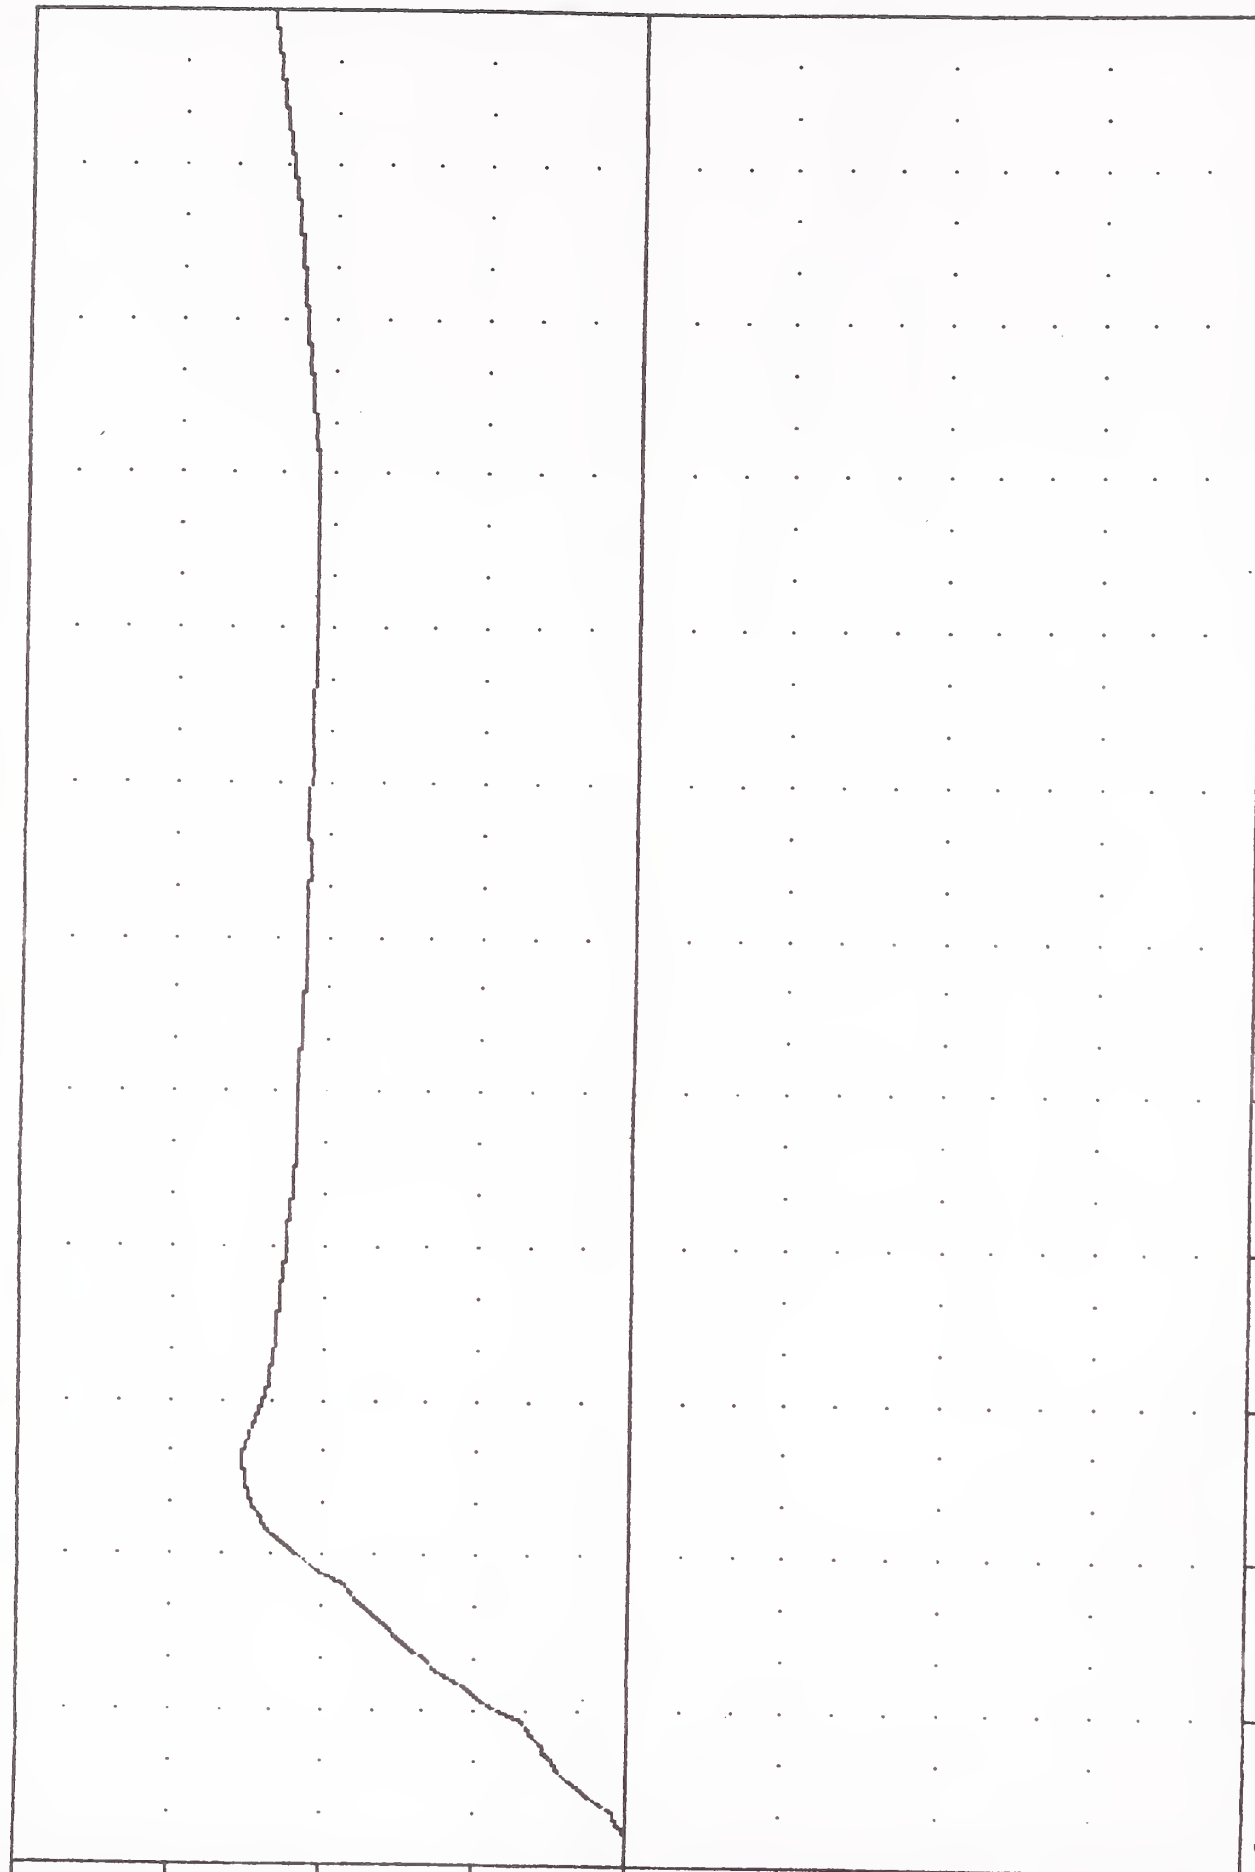
CONTOURED MOVING BARRIER INTO FORO ESCORT AT 28.1 MPH #2
 LEFT FRONT SILL RESULTANT VELOCITY

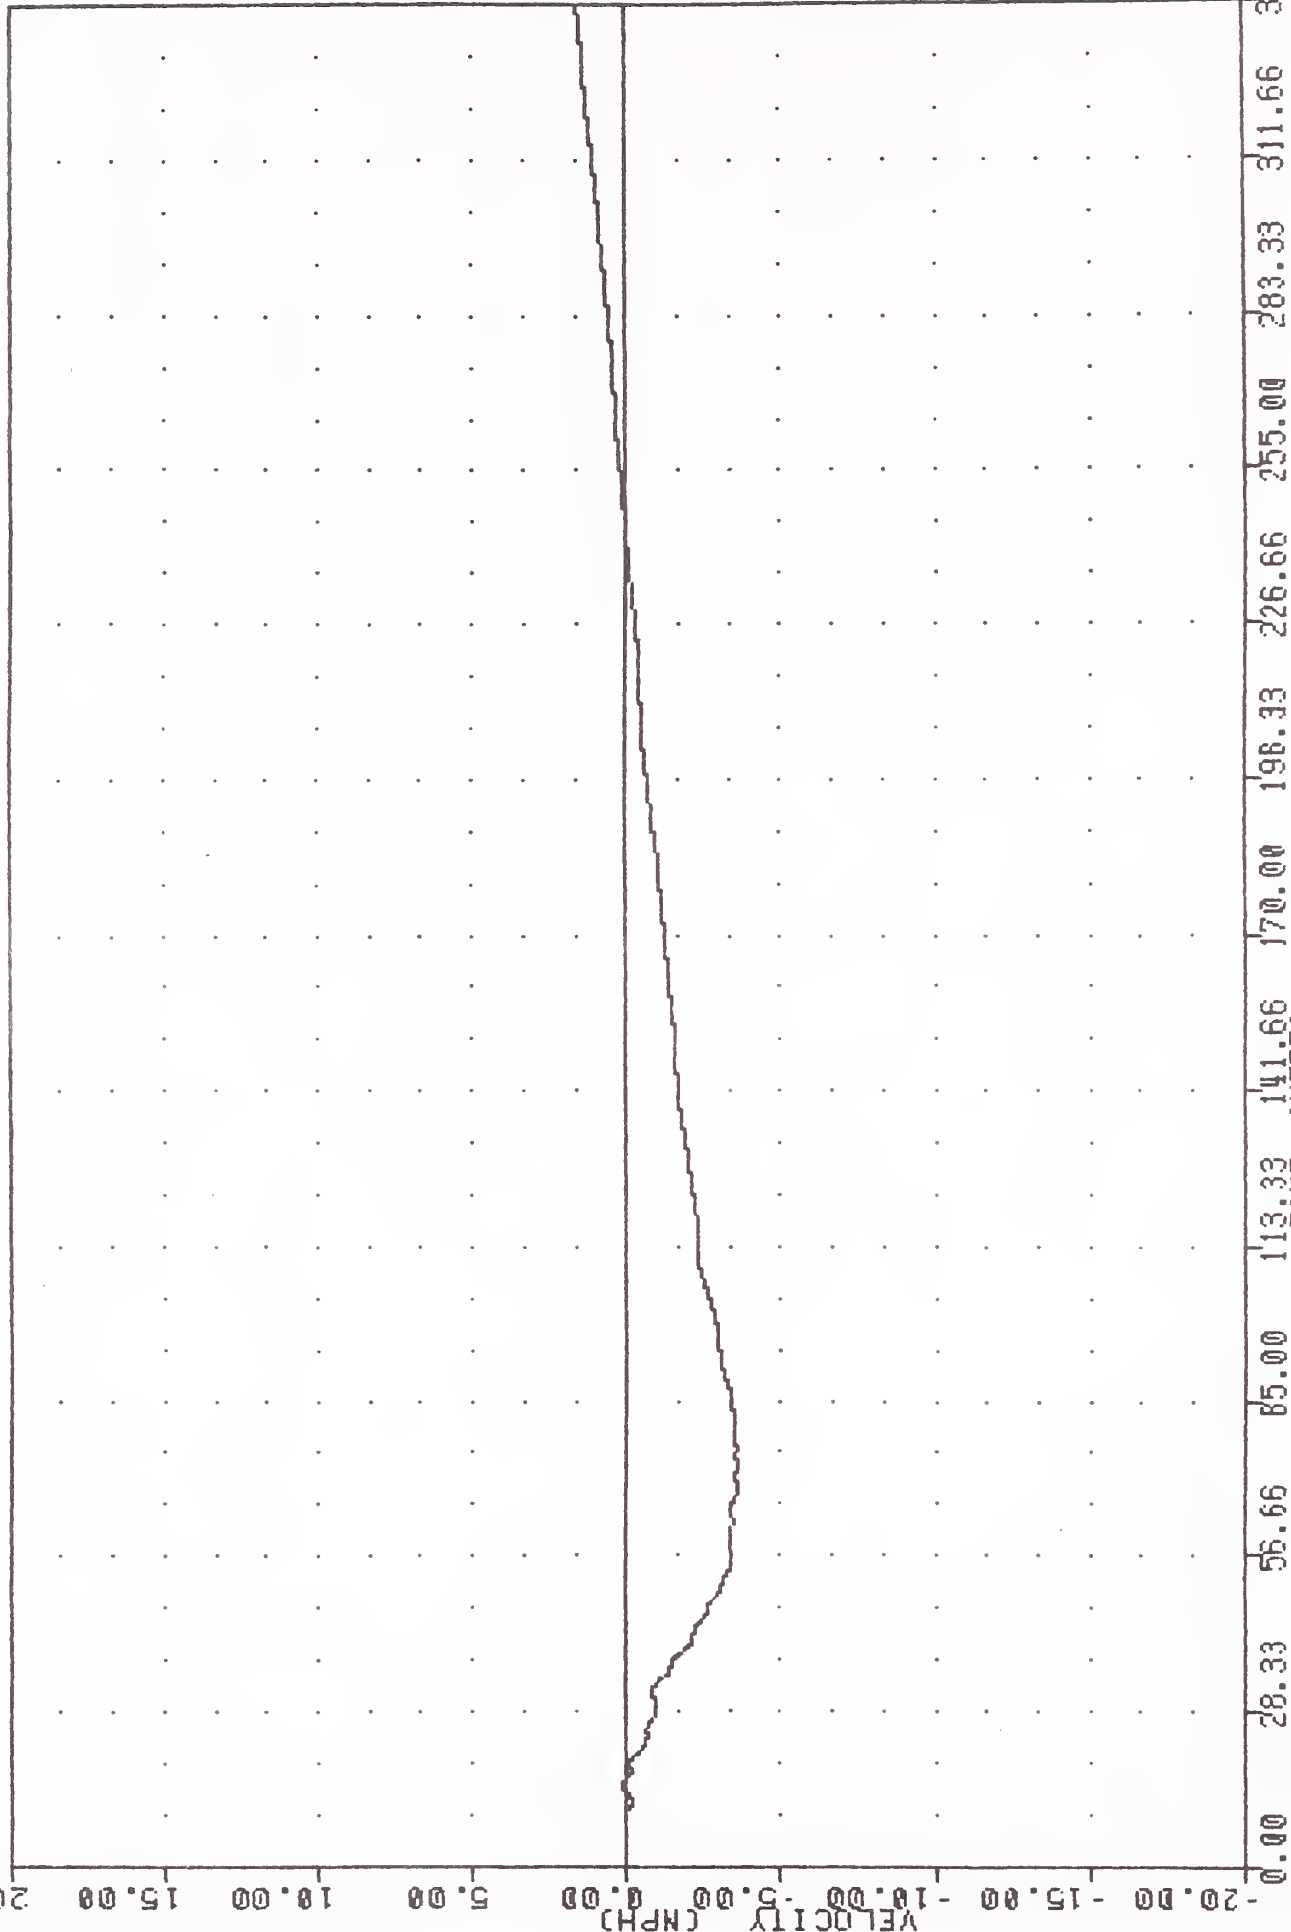
CONTOURED MOVING BARRIER INTO FORD ESCORT AT 28.1 MPH #2
RIGHT FRONT SILL Y-AXIS VELOCITY

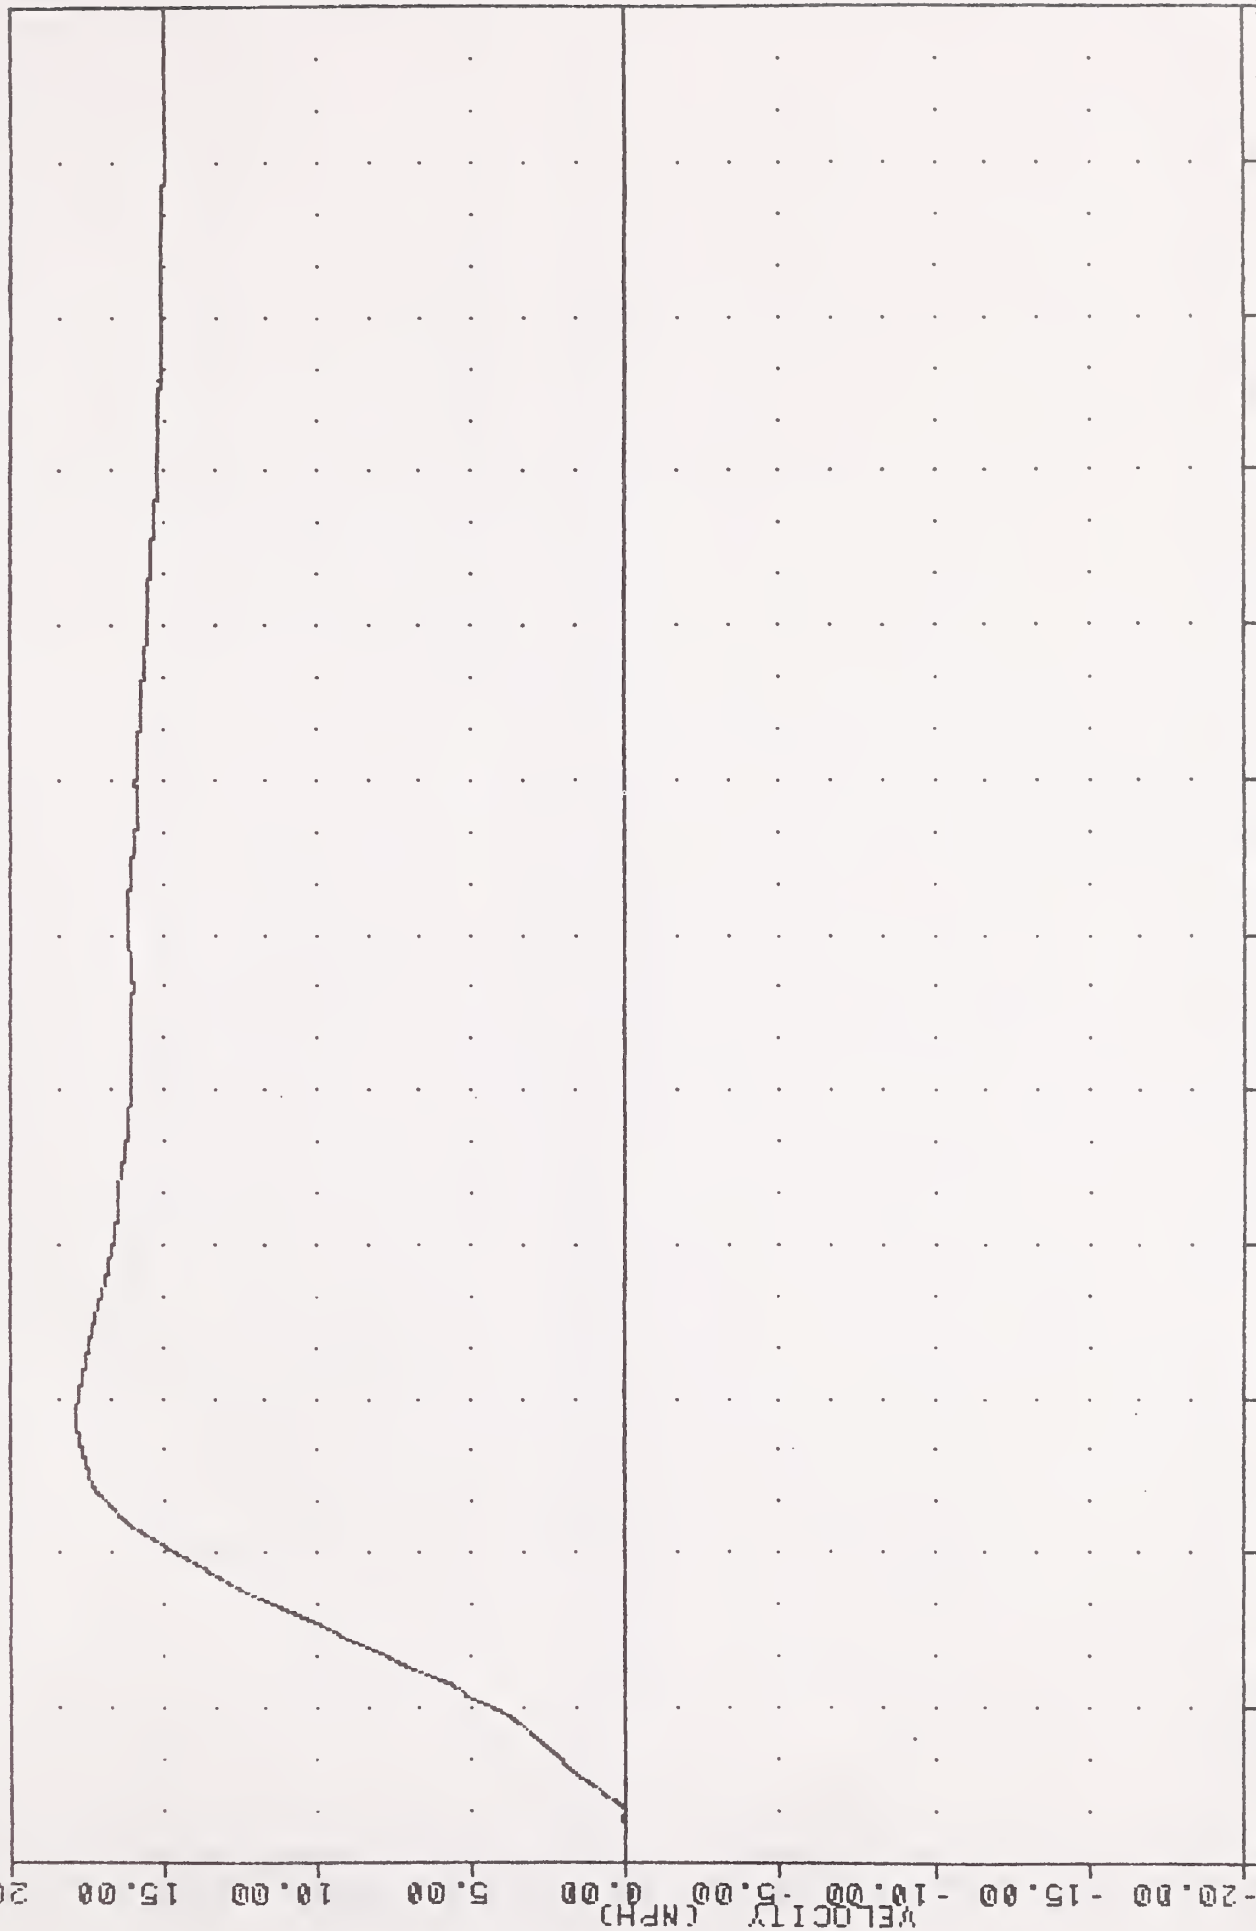
CONTOURED MOVING BARRIER INTO FORD ESCORT AT 28.1 MPH #2
 RIGHT FRONT SILL RESULTANT VELOCITY

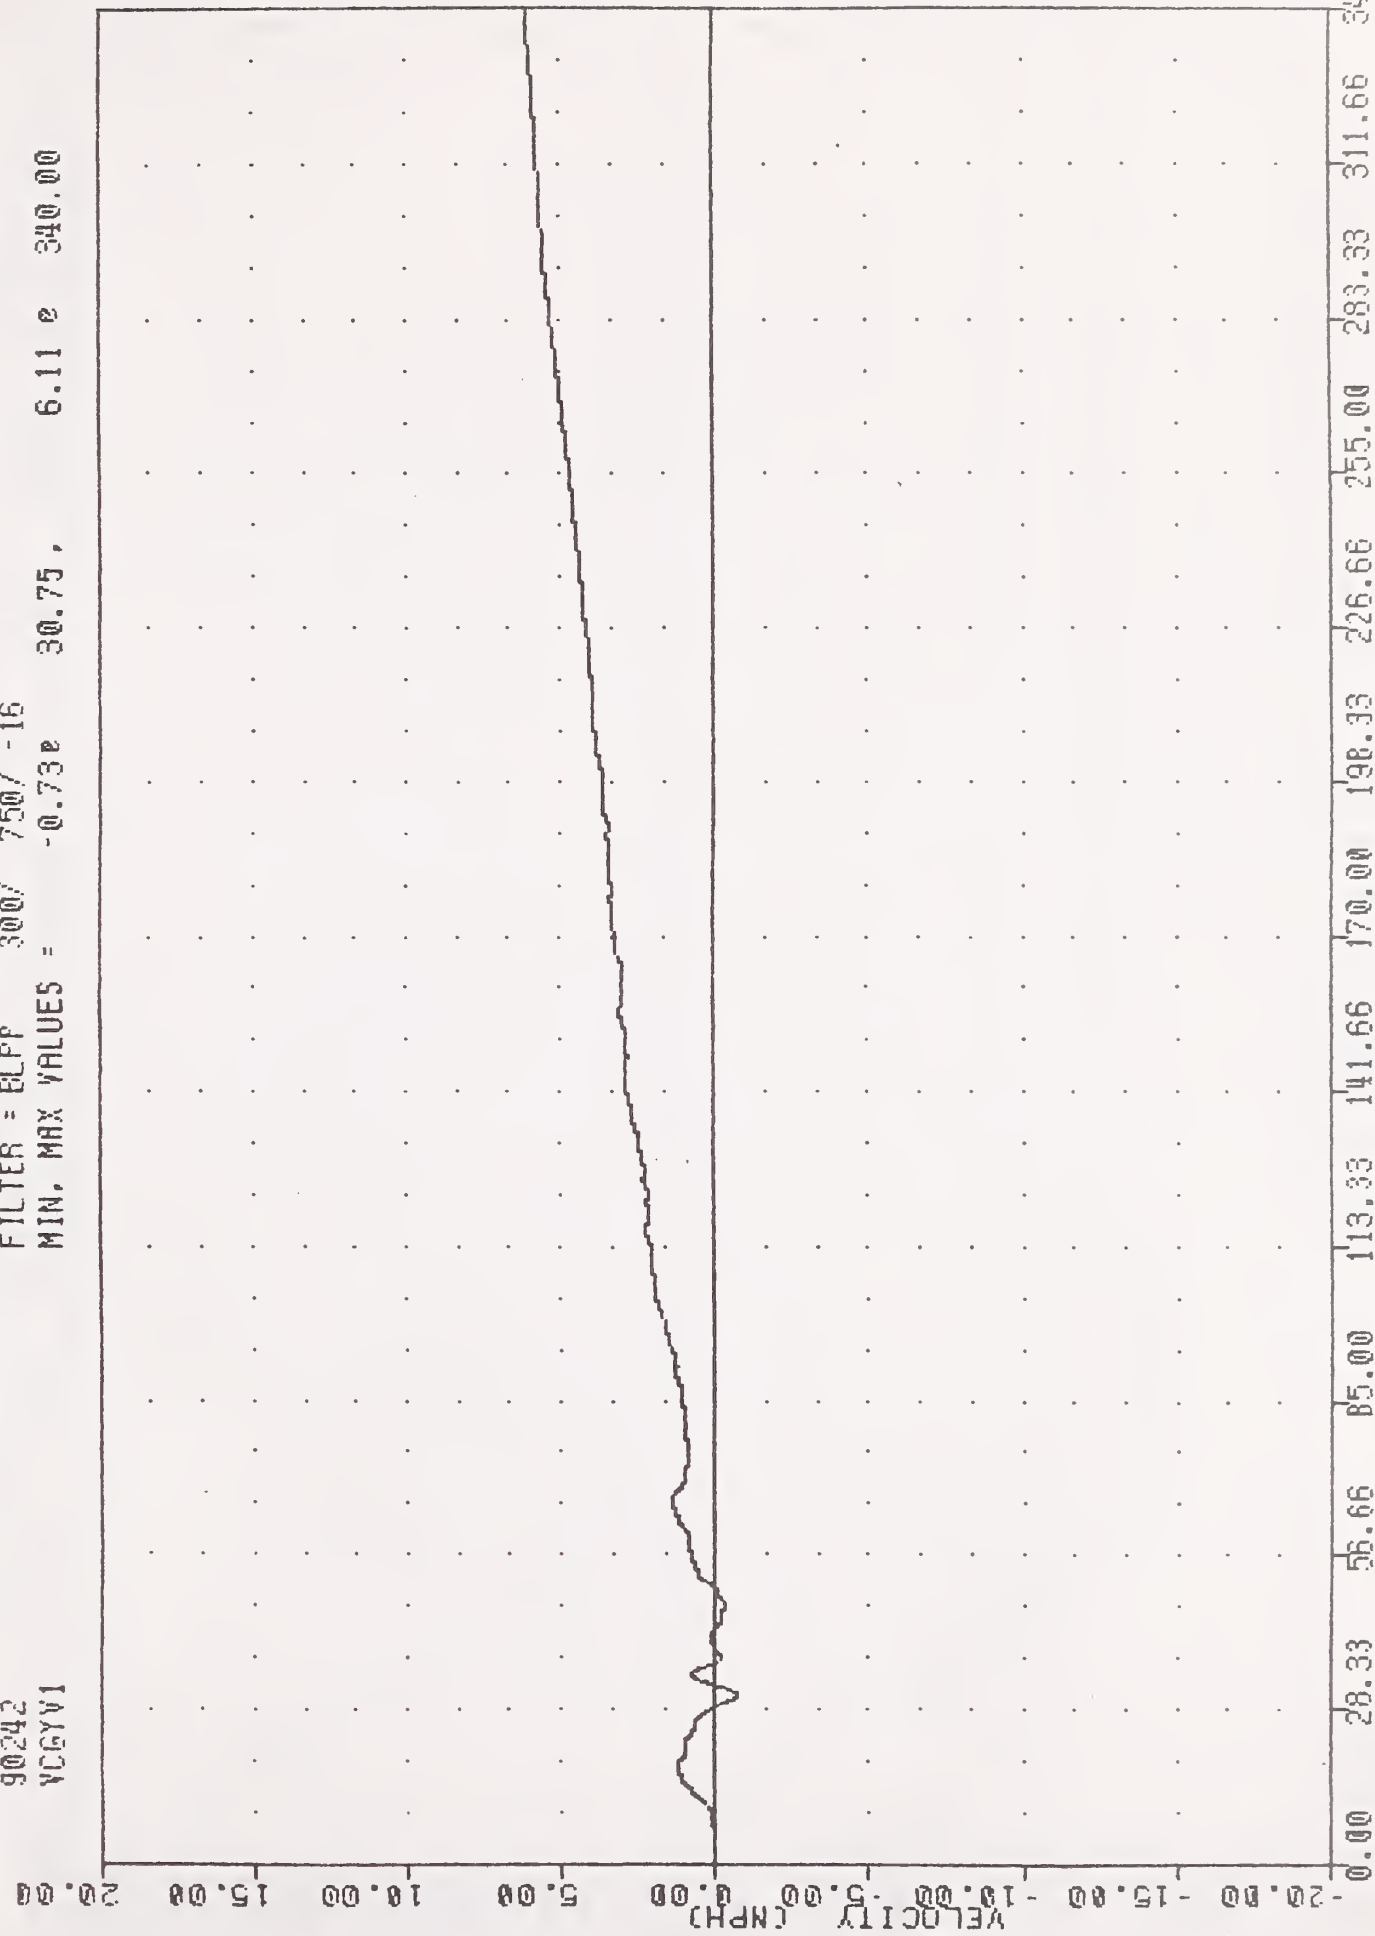
CONTOURED MOVING BARRIER INTO FORD ESCORT AT 28.1 MPH #2
 VEHICLE CG Y-AXIS VELOCITY (PERPENDICULAR TO IMPACT DIRECTION)
